NHTSA'S CRASHWORTHINESS ROLLOVER RESEARCH PROGRAM

Transportation Research Center, Inc.
United States
Paper Number 05-0279

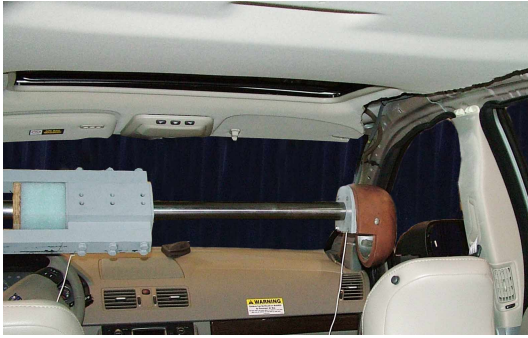
Guided Impactor - NHTSA has been conducting research on ejection mitigation for several years. Since full-vehicle rollover crash tests have substantial variability in vehicle and occupant kinematics [2], it is necessary to develop a component-level test to evaluate the performance of potential ejection mitigation systems. Previous research with advanced side glazings has shown that guided impact testing is an acceptable method for measuring excursion. NHTSA's advanced side glazing status report [3] details the development of an impactor designed to replicate the loading of an occupant's head and shoulder during typical ejection situations. In brief, it consists of an 18 kilogram mass guided through a bearing attached to two supporting rails (see Figure 1). An existing featureless free-motion headform was selected for the impactor face. This rigid headform, covered with a headskin, was originally designed for the upper interior head protection research program. It averages the dimensional and inertial characteristics of the frontal and lateral regions of the head into a single headform [4]. Since it is a guided impactor, only uni-axial motion is measured, and it is capable of measuring dynamic deflection during an impact. The propulsion unit is based on a device by the General Motors Corporations [5], scaled to accommodate the heavier mass. The impactor can be placed inside the vehicle for testing the side window areas, and it can be positioned to strike different locations in those areas.

Figure 1. 18 Kg guided impactor.

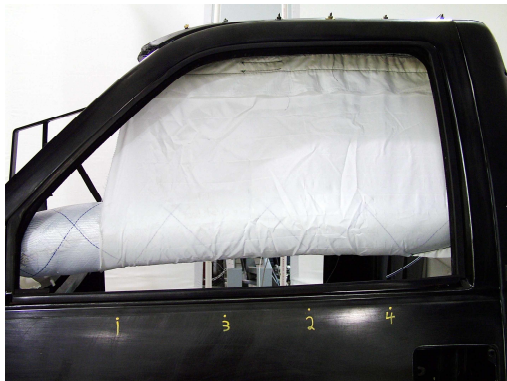
Ejection Countermeasure Candidates - Three ejection countermeasures were examined: two experimental roof rail mounted inflatable systems and advanced side glazings developed under previous NHTSA research. Details of the countermeasures used in testing can be found in reference 6, with one exception. The inflatable device known as the Advanced Head Protection System (AHPS®) developed by Zodiac Automotive US (formerly Simula Automotive Safety Devices, Inc.) was furnished with a modified design that allowed the device to deploy closer to the bottom of the window opening, thus providing more window coverage than the previous design (see Figure 3). The other inflatable system tested, a prototype window curtain provided by TRW, is shown in Figure 4.

Figure 3. Modified advanced head protection system (Zodiac).

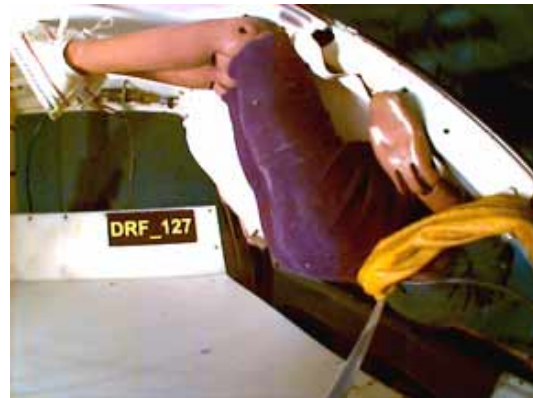
The dummy was completely ejected at both positions 1 and 2 in testing with the TRW prototype window curtain, while the modified AHPS contained the dummy inside the test buck in all testing. Figure 10 shows the prone 6-year old dummy being ejected under the TRW bag at position 1. Adding pre-broken advanced laminated glazing with the TRW system produced better results. The combined system contained the dummy inside the test buck in all tests conducted with this configuration.

Figure 10. 6-year old dummy ejection.
